Public Hearing on a Resolution authorizing the demolition of an unsafe building constituting a public nuisance located at 13032 Chaney Thompson Rd Se, Huntsville, AL; and consideration of a Resolution pertaining to the same.

OFFICIAL NOTICE NO. CE-26-367

NOTICE TO DEMOLISH STRUCTURE VIOLATIONS

**CITY OF HUNTSVILLE COMMUNITY DEVELOPMENT
STRUCTURAL EVALUATION REPORT**

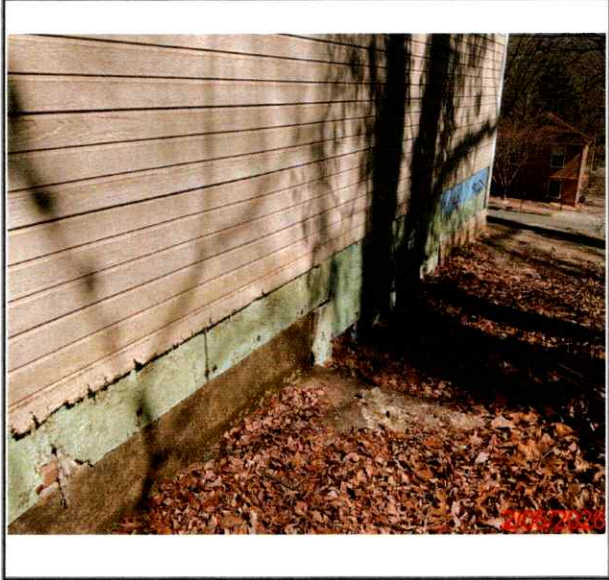
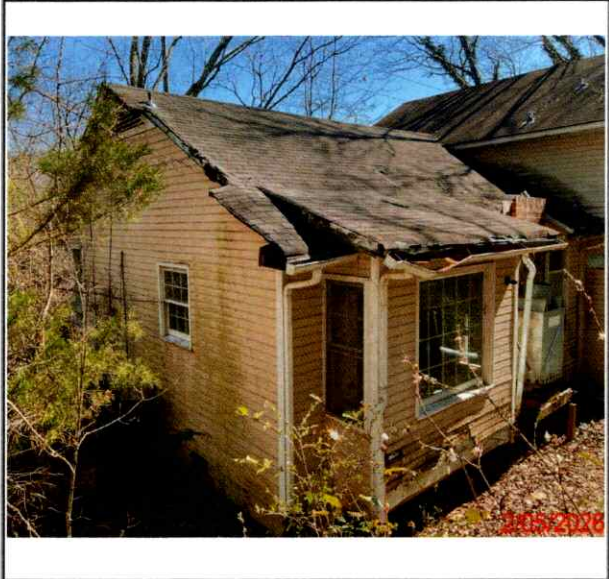
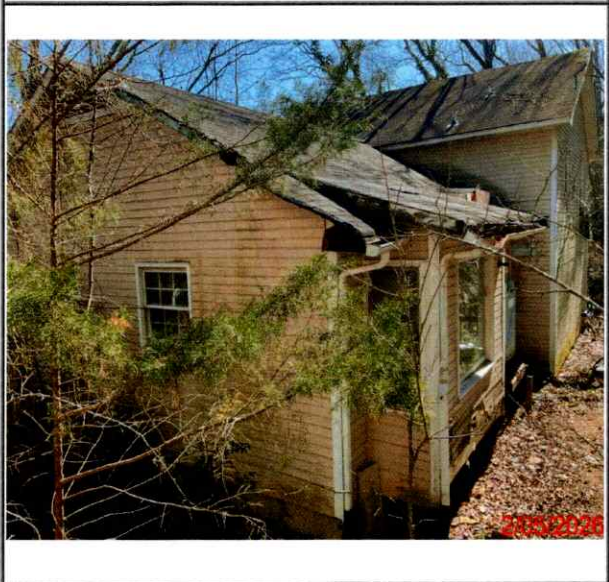
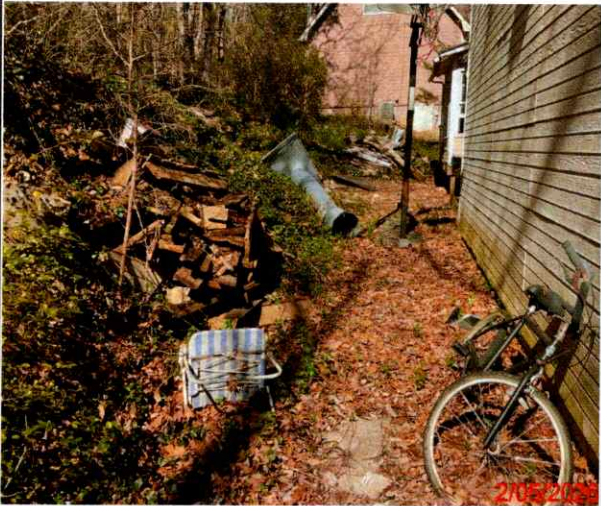
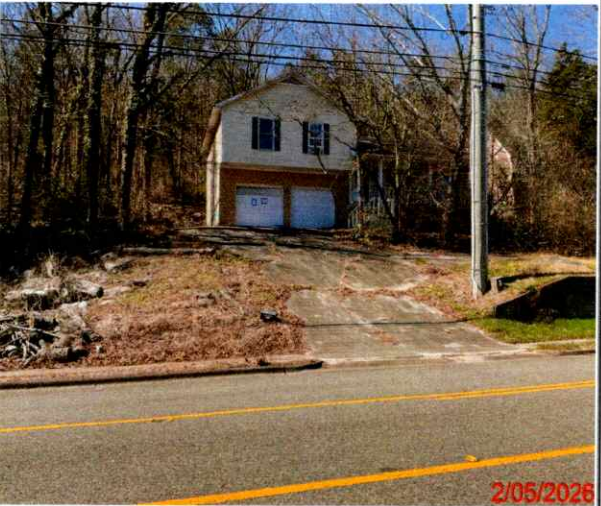
Photo	Details

Roof has holes: rear, right
Roof damaged: rear, right
Roof covering loose: rear, right
Walls damaged: rear, right
Walls have holes: rear, right
Siding rotted: left, rear, right
Siding damaged: rear, right
Gutters damaged: rear
Gutters have holes: front, rear, right
Door missing: rear
Steps damaged: front
Steps rotted: front
Ceiling has holes
Ceiling damaged
Walls damaged
Floors damaged

This structure must be demolished and removed prior to 03/26/2026

REMARKS: I INSPECTED PROPERTY ON FEB. 5TH 2026, I CONCLUDED THAT PROPERTY IS IN NEED OF EXTENSIVE REPAIRS AND WOULD NOT RECOMMEND TO RE-CONSTRUCT
