Public Hearing on a Resolution authorizing the demolition of an unsafe building constituting a public nuisance located at 3208 Tenth Ave Sw, Huntsville, AL and consideration of a Resolution pertaining to the same.

**OFFICIAL NOTICE NO. CE-26-1471 REVISED**

**NOTICE TO DEMOLISH STRUCTURE  
VIOLATIONS**

CITY OF HUNTSVILLE COMMUNITY DEVELOPMENT  
STRUCTURAL EVALUATION REPORT

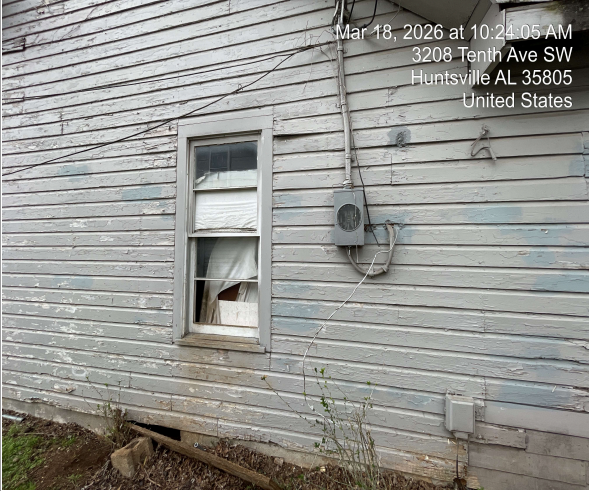
| Photo | Details |
|---|---|
| A photograph of the exterior wall of a house with horizontal siding. A window is visible, and a utility meter is mounted on the wall. The photo is dated Mar 18, 2026 at 10:24:05 AM, 3208 Tenth Ave SW, Huntsville AL 35805, United States. | <p><b>Title:</b> IMG_6783_1773924878364.JPG</p> <p><b>Date:</b> Mar 19, 2026 07:55</p> <p><b>Uploaded by:</b> James Smith</p> |

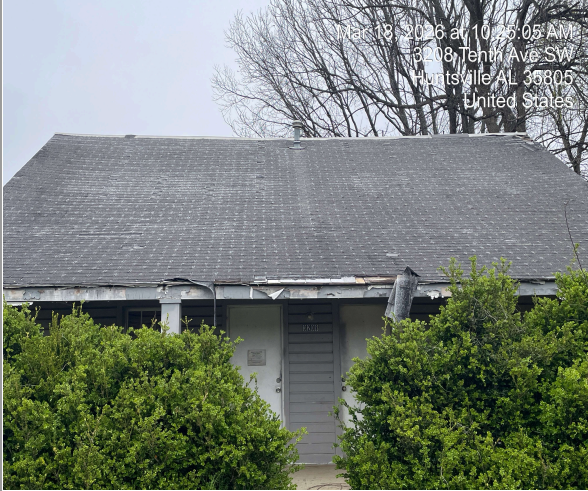
| Photo | Details |
|---|---|
| A photograph showing the front entrance of a house. The door is grey and has a small window. It is flanked by two large, dense green bushes. The roof is dark grey and appears to be made of shingles. The sky is overcast. <p>Mar 18, 2026 at 10:25:05 AM<br/>3208 Tenth Ave SW<br/>Huntsville AL 35805<br/>United States</p> | <p><b>Title:</b> IMG_6794_1773924878386.JPG</p> <p><b>Date:</b> Mar 19, 2026 07:55</p> <p><b>Uploaded by:</b> James Smith</p> |

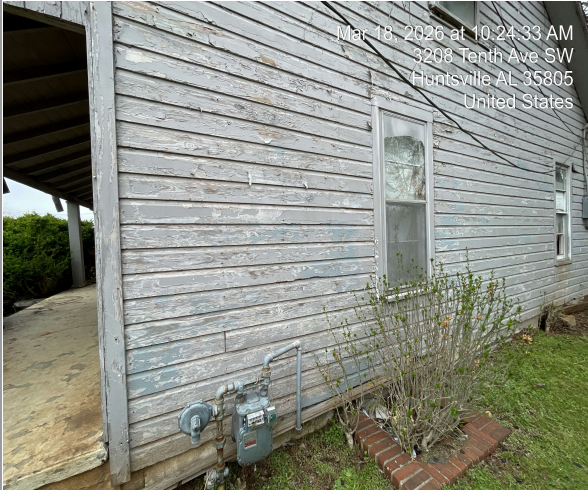
| Photo | Details |
|---|---|
| A photograph showing the side of a house with horizontal siding. There is a window with a white frame. A small bush is in the foreground. A gas meter is visible on the side of the house. <p>Mar 18, 2026 at 10:24:33 AM<br/>3208 Tenth Ave SW<br/>Huntsville AL 35805<br/>United States</p> | <p><b>Title:</b> IMG_6789_1773924878388.JPG</p> <p><b>Date:</b> Mar 19, 2026 07:55</p> <p><b>Uploaded by:</b> James Smith</p> |

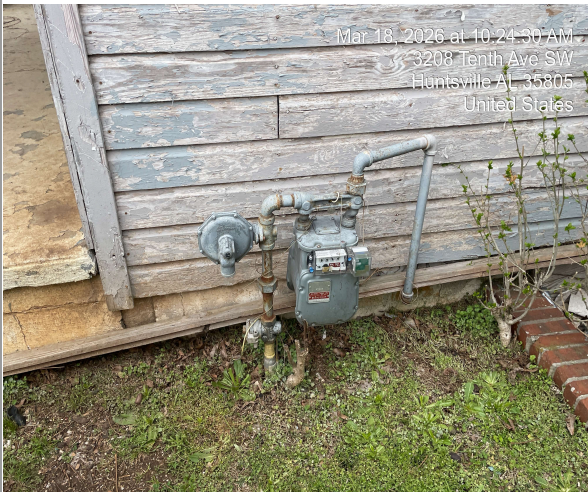
| Photo | Details |
|---|---|
| A close-up photograph of a gas meter mounted on the side of a house. The meter is grey and has various pipes and valves connected to it. The siding is horizontal and appears to be made of wood or a similar material. <p>Mar 18, 2026 at 10:24:30 AM<br/>3208 Tenth Ave SW<br/>Huntsville AL 35805<br/>United States</p> | <p><b>Title:</b> IMG_6788_1773924878396.JPG</p> <p><b>Date:</b> Mar 19, 2026 07:55</p> <p><b>Uploaded by:</b> James Smith</p> |
